Davidson Inspection
619.435.0845 Office
619.996.2079 Fax
Jen@DavidsonInspection.com
www.DavidsonInspection.com

November 8, 2011

Re: Anywhere USA

Report Index

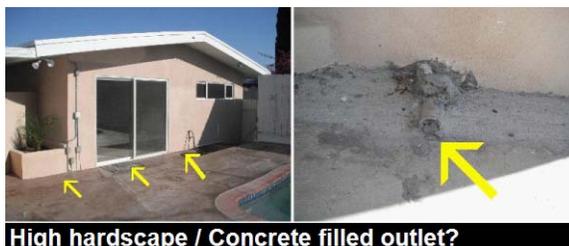
Grade at Foundation:

Monitor - The finished grade level of exterior rear pool area flatwork was too high against the house. Flatwork was in contact with siding material. Ideally, the exterior flatwork should be held at least 2" below the bottom edge of the siding to help protect the siding and structure against moisture damage and termite infestation. Site grading did not allow for surface runoff to drain off the building pad. Surface drainage was directed into drain inlets of the

subsurface drainage system. Consequently, adequate site drainage was dependent on subsurface drains. It is essential that the subsurface drainage system is functional for adequate site drainage. Recommend verifying that the underground drainage system is functional, and recommend flushing drains annually. There appears to be hardened concrete in the drain discharge outlet at the driveway.

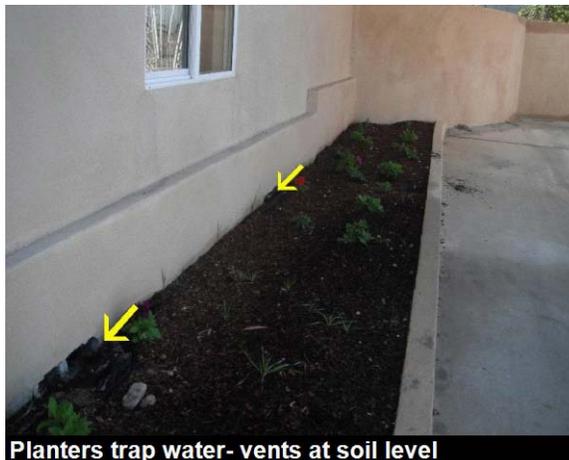
Surface Drainage:

Planters trap water- vents at soil level

Further Evaluation - Raised planter appears to trap water next to the foundation at the right side. Also the crawlspace vents are below the soil level. This can trap moisture against the foundation, and allow water to migrate into the crawlspace. We recommend further evaluation by a licensed landscaping contractor for corrective action to divert water away from the foundation.

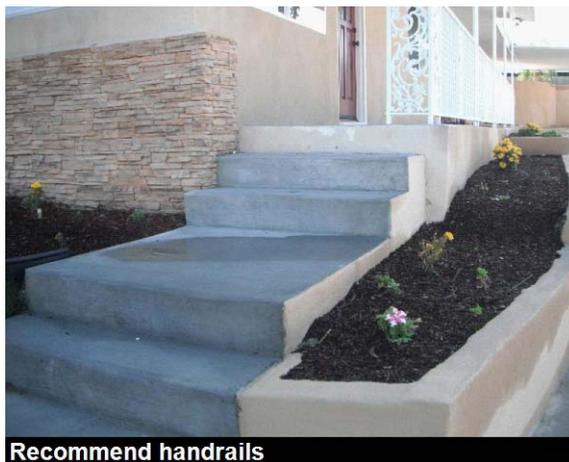
Steps On-grade:

Recommend handrails

Upgrade - Handrails were not installed along exterior steps. Handrails are required where 4 or more risers are present.

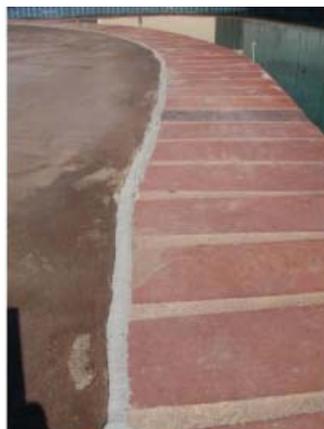
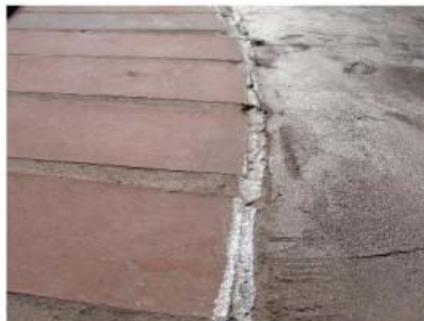
Coping:

Marginal - Caulking has been applied over the existing caulking but is thin in some areas and peeling in other areas. This is a very poor installation.

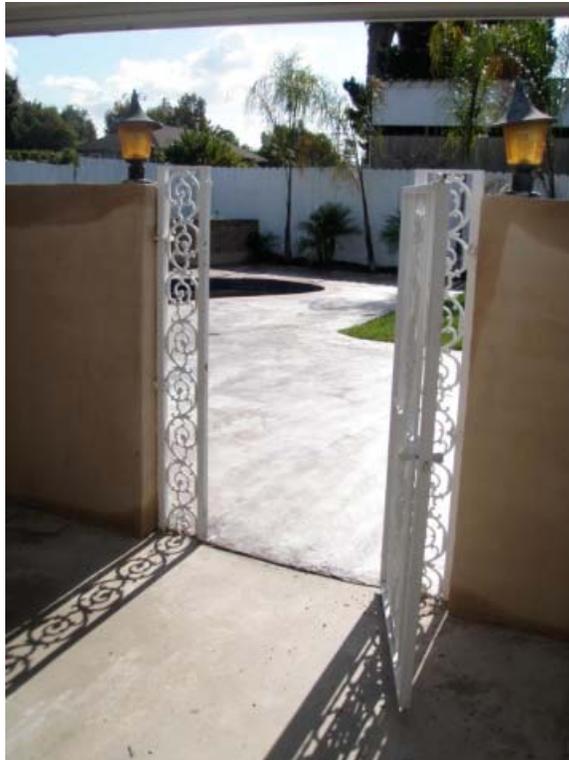
Pool/Spa Enclosure:

Safety - Alarms were not installed on exterior doors that had direct access to the pool/spa.

Safety - The gate does not self close or latch properly. Self closing and latching gates are needed to keep small children out of the pool/spa area.

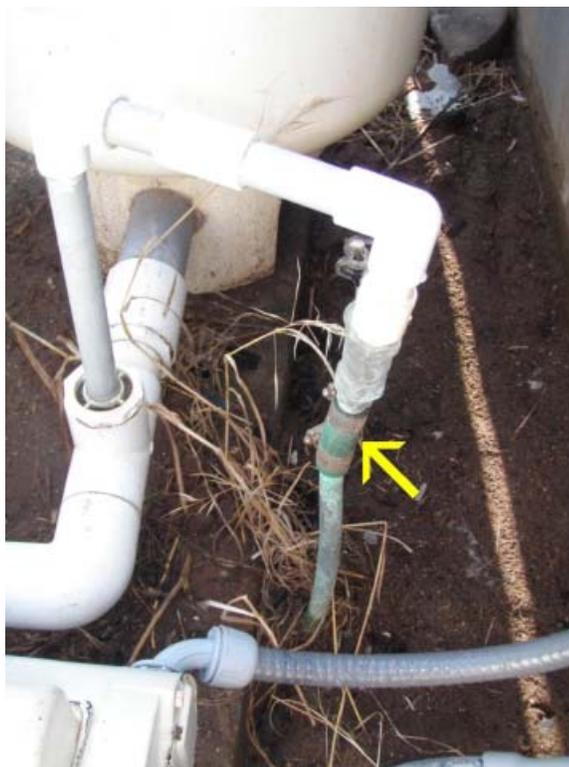
Pool Refill Valve:

Marginal - No pool/spa fill plumbing device installed. Fills/refills with a garden hose. This makes having a anti siphon faucet very important to prevent pool water from mixing with drinking water.

Advisory - There is a water pipe and valve connected to the plumbing at the equipment that appears to be a fill valve but it was not operational. This is a very odd location for a fill valve. We recommend further evaluation and correction as needed at this time by a licensed building contractor.

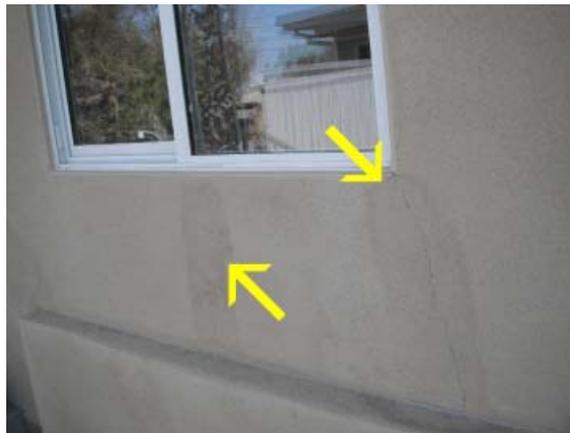
Siding:

Monitor - Patches present at corners of some of the windows. These appear non professional. The color doesn't match, and the cracks are not sealed.

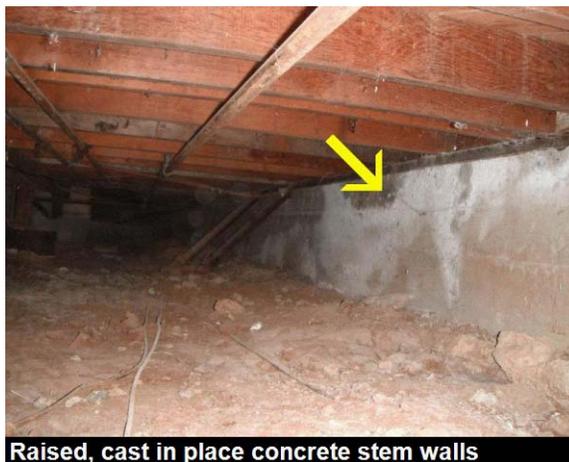
Foundation Type:

Raised cast-in-place concrete stem walls.

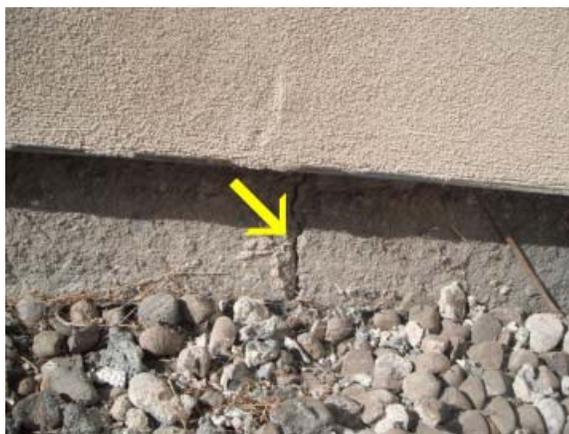
Foundation:

Monitor - Vertical cracks less than 1/8 inch are present. Viewed at left side near the front. A small amount of cracking in the foundation is common and may be a symptom of conditions such as poor drainage, settlement or soil movement. Repairing these types of cracks is generally optional. Minimally, sealing these types of cracks is recommended to prevent air and moisture infiltration. As a precaution we also recommend occasionally monitoring them for change. Any noticeable change should be further evaluated by an engineer.

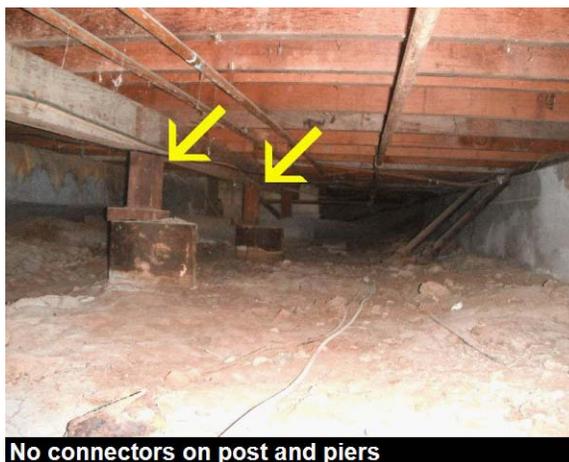
Columns & Supports:

Upgrade - Metal straps were not installed for connecting posts to piers and beams. These straps were not required in houses built prior to the 1980's, but their installation has proved effective in keeping these structural members joined in the event of an earthquake.

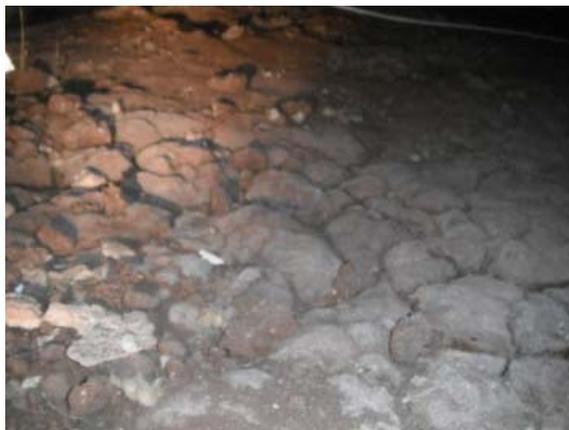
Under-floor Areas:

Advisory - Signs of past water entry were present. The source of the moisture was not determined, and the crawlspace is dry at this time. This is usually an indication that drainage around the foundation needs to be corrected/improved. It is important to take action in order to prevent damage to the foundation.

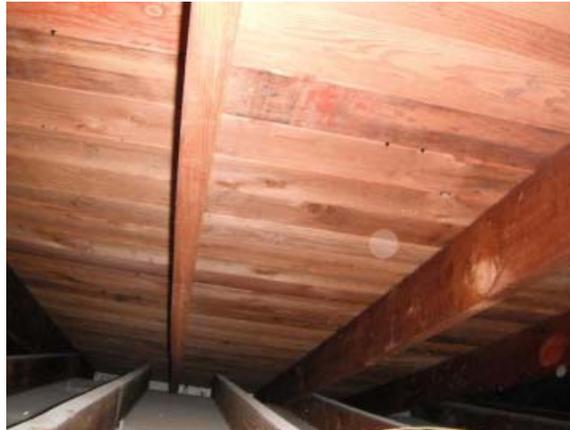
Roof Sheathing:

1x solid decking.

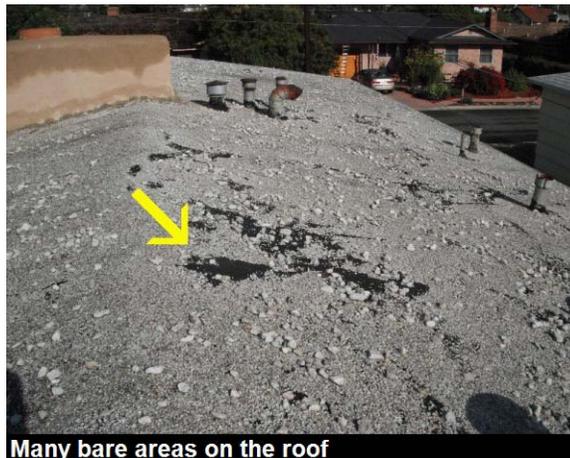
Roof Maintenance:

Many bare areas on the roof

Repair / Replace - Bare areas were observed. The underlying felt membrane was exposed. Many areas lack gravel embedment. Recommend evaluation by licensed roofing contractor.

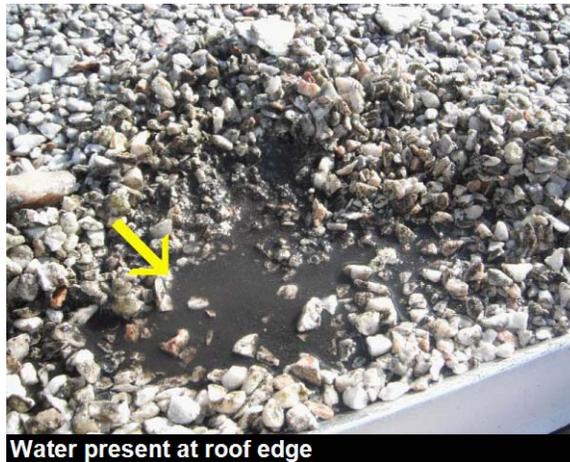
Built-up Flat Roof:

Further Evaluation - There was evidence of ponding at the roof edge. Poor drainage promotes water infiltration and can reduce the service life of the roof.

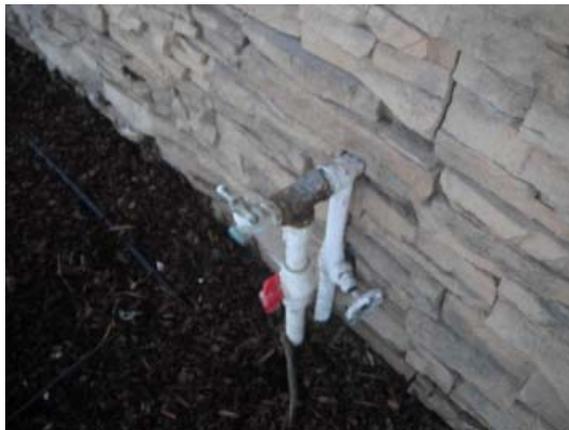
Water Main & Shutoff:

Located at exterior front. The main shutoff valve was not operated.

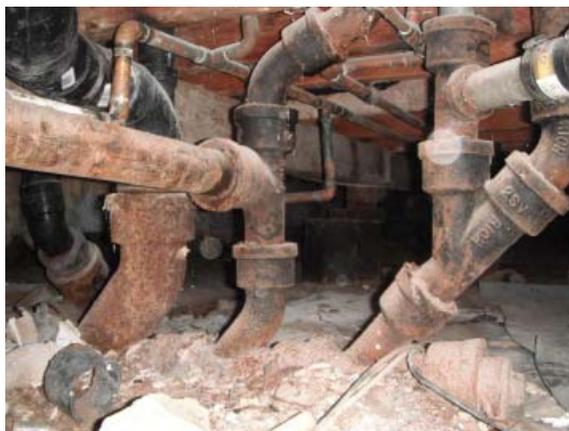
Wastewater Pipes:

Further Evaluation - The cast iron drain pipes were old. Rust/corrosion was present. Repairs had been made to the system at some areas. Ongoing repairs should be anticipated as this older system continues to age. Replacing the entire system will eventually need to be undertaken. The cast iron drain system was as old as or nearly as old as its expected service life. Underground drain pipes could not be judged. We recommend asking the owner if there is a history of sewer blockage. We also recommend inspection by a qualified plumbing contractor using a 'snaking' video camera.

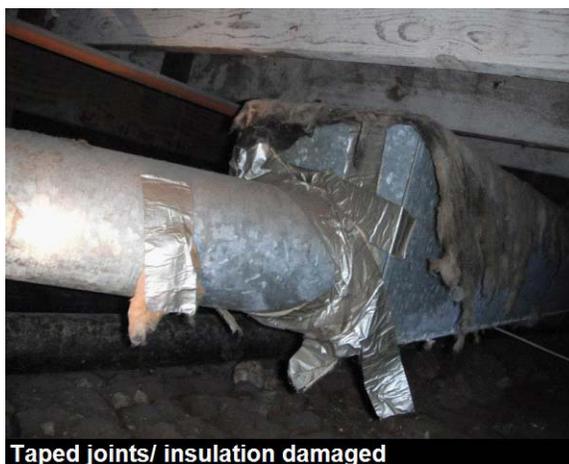
Air Ducts / Distribution:

Further Evaluation - Ducting appears to be from an older system and was not repaired/upgraded when new heating/cooling units were installed. Insulation is missing on the ducting and taped joints appear to leak. The airflow was low at the registers.

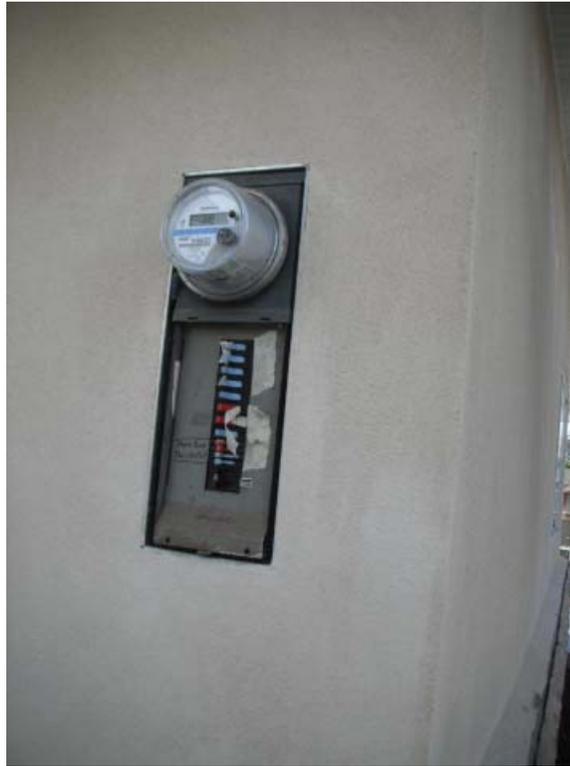
Panel - Access/Enclosure:

Safety - The exterior cover panel was missing. Consequently, the electrical panel lacked basic weather protection. This is a serious safety defect that should be corrected by a licensed electrician.

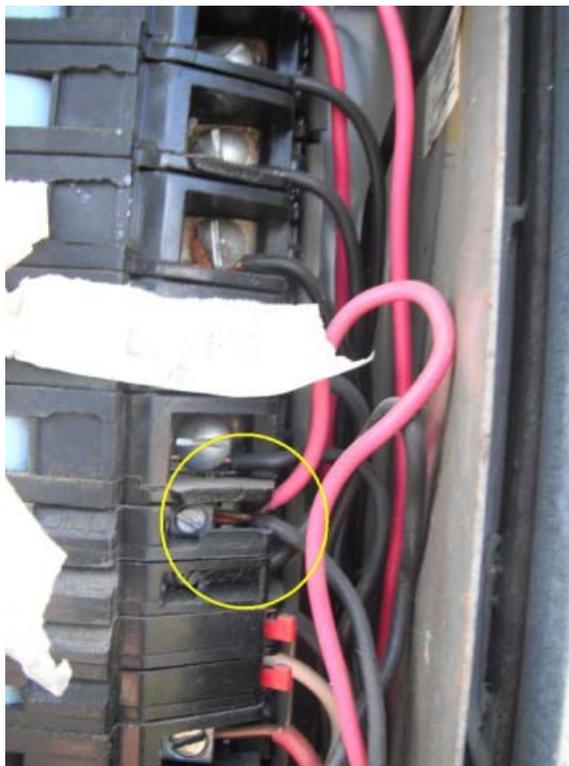
Panel - Breakers/Wiring:

Safety - Breaker(s) were "double lugged", meaning 2 conductors are connected to one breaker. Double lugged circuits are at greater risk of over loading and causing the breaker to trip due to the additional demand from the second wire load. Also, wiring may become hot due to a loose connection with a double wire contact. Double lugged circuits should be separated and a new breaker installed to receive the second wire.

Further Evaluation - The kitchen has been remodeled / up-graded but the electrical breakers have not. Current standards require a dedicated 20 amp circuit for the counter outlets, refrigerator, dishwasher, disposal, microwave and lighting. This panel does not appear to meet this standard. We recommend further evaluation and correction as needed at this time by a licensed electrical contractor.

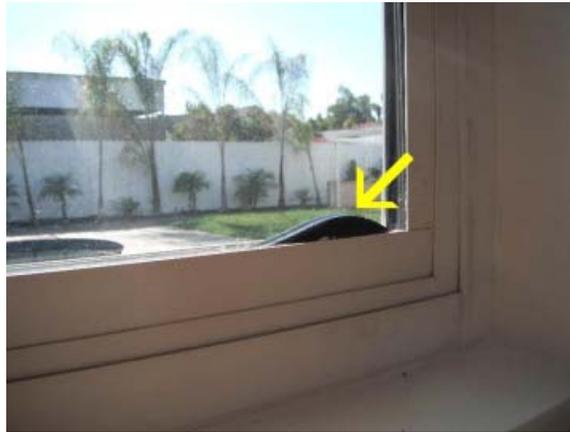
Windows:

Further Evaluation - Window(s) weather strip has come out of place in the master bedroom. Recommend evaluation by a licensed glazing contractor.

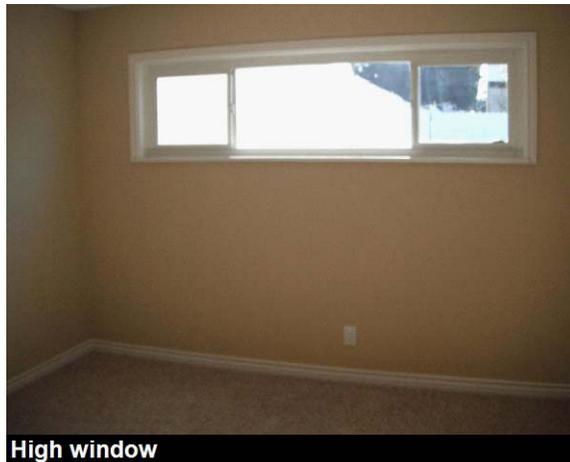
Escape & Rescue:

Upgrade - Window(s) did not meet emergency egress requirements at master bedroom. Window sill(s) were noticeably too high above the floor. A window sill should not be higher than 44" by current safety standard (46" by old standard).
